Investigating Corrosion Protection of Offshore Wind Towers

Part 2: Results of the Site Tests

This article is the second part of a report on a nationally funded project on the performance testing of different corrosion protection methods for offshore wind towers under site and laboratory conditions. Part 1, published in the April 2008 *JPCL*, reported on the rationale behind, and setting up of, the test program. The present article discusses the test results.

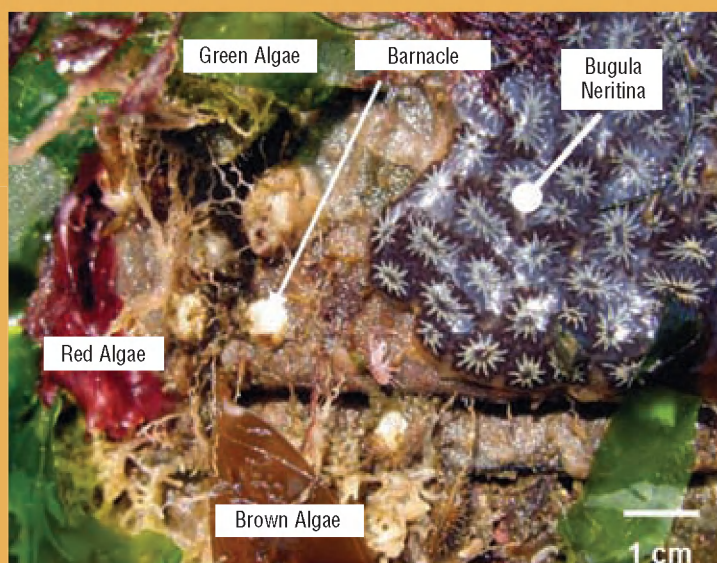
*Fig. 1: Fouling at an underwater zone (UZ) specimen
 Photos and figures courtesy of the authors*

All UZ samples were heavily fouled (as shown in the upper three rows of Table 2). Species found on the test specimens included brown algae (*Laminaria*) with large brown leaves up to 2 m long. They appeared predominantly in the upper region of the UZ. Further on, green algae (*Ulva*) were found, as were at least three species of red algae, which were not classified (Fig. 1). Moreover, the following types of species were identified: sponges, mussels (common mussel, oyster-type mussel), anemones, bryozoan (very striking was the species *Bugula neritina*) and sea firs. One special kind of barnacle (*Balanus crenatus*) could be found in the UZ only. This species features a calcareous basal plate, which could not be dislodged completely, even when the barnacles were removed from the specimens (Table 2). This species was reported to likely occur in the UZ of wind towers in the North Sea.⁴ Vagile (mobile) species were detected as well, among them worms, some crabs (Fig. 2), and small fish (up to 20 cm long). The settling of numerous species of crabs and fish at submerged wind tower sections in the North Sea was also reported.⁶ Algae could not be detected at the rear side of the sample plates because of lack of sunlight in that area.

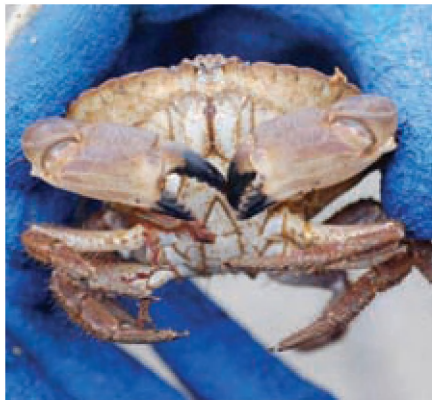
Fig. 2: Great crab, domiciliated in the underwater zone (UZ)

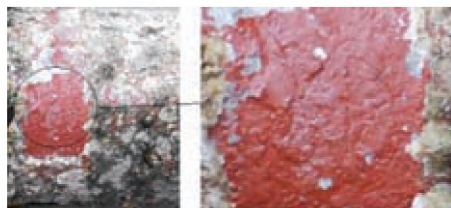
Fig. 3: Coating delamination at System 5 after 36 months of UZ exposure

System 6 exhibited large-scale blistering and severe coating delamination. This sample could not be cleaned properly because high-pressure washing would have removed the deteriorated coating. The sample showed white corrosion products, which were identified as the corrosion product of the metallization. The total system could be removed by scratching it slightly with a fingernail (Fig. 3). Because metallization with adequate sealers (at least Al/Zn metallization) is usually an effective and proven method for protecting offshore steel structures,^{10,11,12} the result was surprising. No conclusive explanation can be delivered at the moment, and

this issue will be the topic of a subsequent study. It is not clear whether fouling effects contributed to that failure. The compatibility of this coating system with cathodic protection under laboratory conditions was good (See Part 3 of this series, to be published in an upcoming issue).

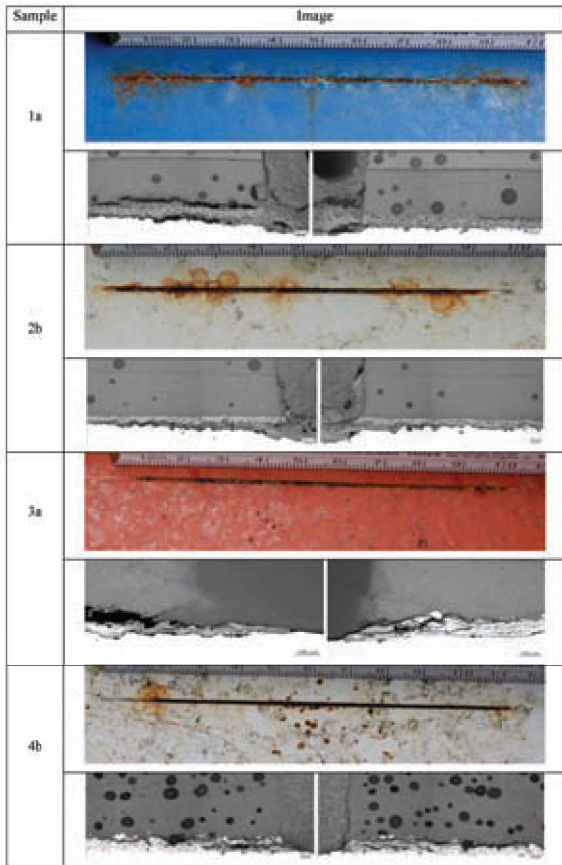
Table 7: Corrosion (upper image) in, and Paint Delamination (lower image; cross section view) at the Artificial Scribe at the IZ Specimens

Notable effects were found for Systems 1 and 2. The scribe delamination was about 2 mm for sample 1a and about 1 mm for sample 1b. The sample 1a exhibited severe corrosion at the scribe (Table 7). Scribe delamination was about 2 mm for sample 2a and about 3 mm for sample 2b. Both samples for System 2 showed limited corrosion at the artificial scribe. Sample 1a exhibited blistering up to a distance of 10 mm from the scribe.

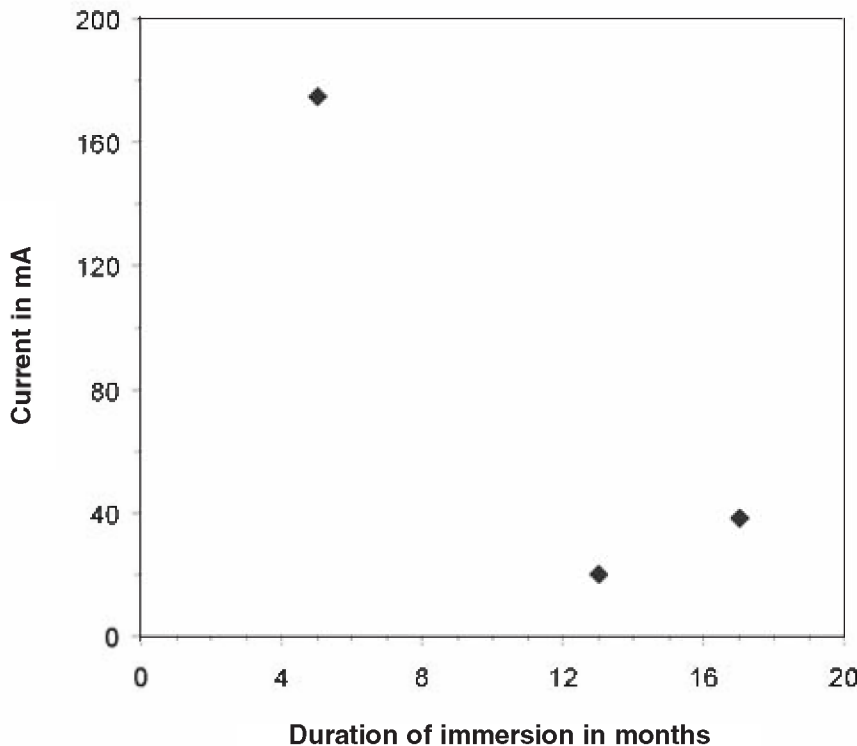
Fig. 4: Current consumption of cathodic protection of UZ samples

cathodic protection measurements. During the first months, the sample remained unprotected for technical reasons. The current had rather high values, which may have been caused by initial corrosion of the unprotected samples. After the cathodic protection was introduced, the value for the current dropped, and it seemed to be constant for the entire exposure phase. Coverage by fouling and the precipitate of alkaline earth salts are two probable reasons for the continuously low values for the protective current. Unfortunately,

part of the cathodic protection device was destroyed due to heavy wave load after 17 months, and it did not work properly. Therefore, the cathodic protection failed, and the uncoated sections of the specimens started to corrode.

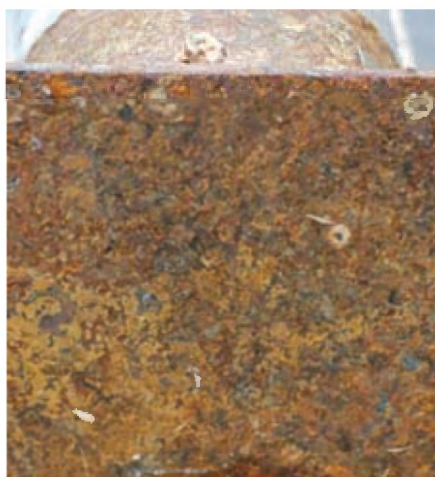
Fig. 5: Unprotected section of a UZ specimen after 36 months of exposure

The uncoated sections featured two layers of corrosion products (Fig. 5). The layer next to the steel was a black, loosely adherent layer, which was identified as Fe-oxide, more specifically, Fe-hydroxide with a low oxidation number. The top layer was the typical red rust, also loosely adherent. Figure 6 provides an SEM image and an EDX spectrum taken from the external corroded wall of the uncoated section of an UZ specimen. It can be seen that the rust was already cracked. Crack lengths ranged from 0.25 to 1.5 mm. Rust flakes were partly separated and only loosely adhering to the steel. The honeycomb structure in the far right region of the photograph is residue of fouling, and may be the origin of Si and partly of S and Na, occurring in the

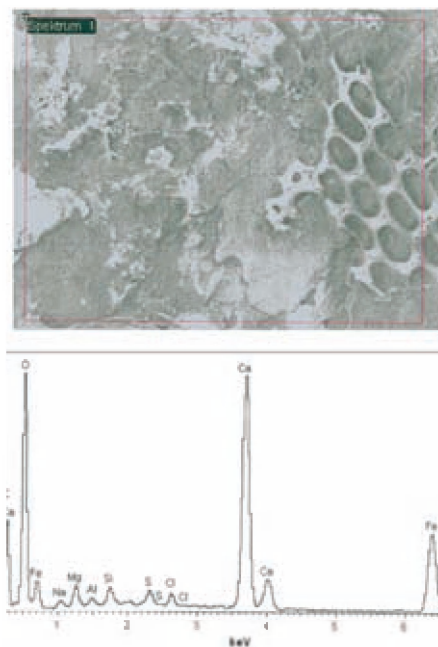
Fig. 6: SEM image (upper image; image width: 5 mm) and EDX plot (lower diagram) of the corroded external wall of UZ specimen 2 after 36 months exposure

EDX spectrum. The Fe-peaks in the spectrum originate from the corrosion products formed at the surface. The elements Al, Cl, Ca, Mg, S, and Na are constituents of the seawater.
