Effect of a 100 Watt ultrasound transmitter on marine fouling

Lodewijk van Walraven & Louis Peperzak

This report is part of project DMEC WP 3.3.

Texel, April 2018
NIOZ Royal Netherlands Institute for Sea Research

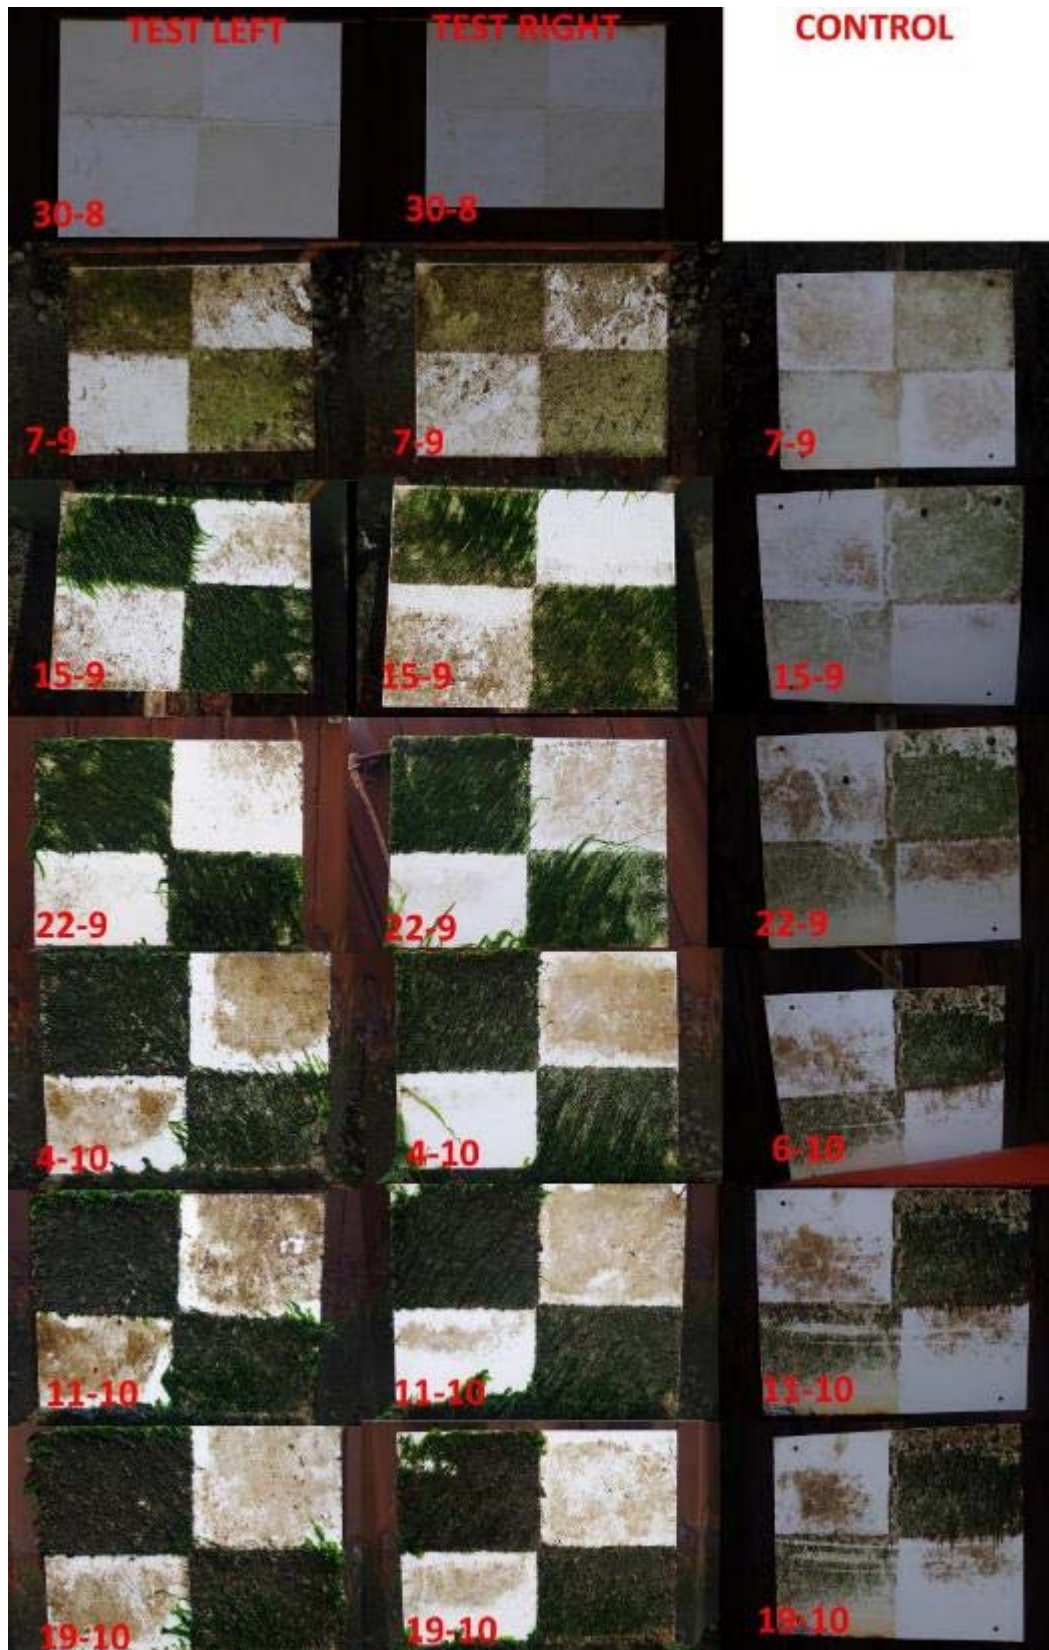
After the first biofilm a rapid growth took place on all test and control plates (Figure 9). The densest growth was observed on the test plates with control coating exposed to ultrasound, followed by the test plates with anti-fouling coating exposed to ultrasound.

Already after three weeks the biofilm was succeeded by a dense cover of macroalgae on the test plates with control paint. A similar macroalgal cover was observed on the control paint quadrants on the control plate, but it developed slower and the overall “greenness” was lower than on the test plates exposed to ultrasound. Also visible on the test plates were marks made by collision with floating objects, as well as grazing trails by periwinkle snails *Littorina littoralis*.

Figure 9. Mosaic of photos taken of antifouling test plates. Note that weather and water conditions prevented photographing the test plate on this day. The test plates are photographed upside down.

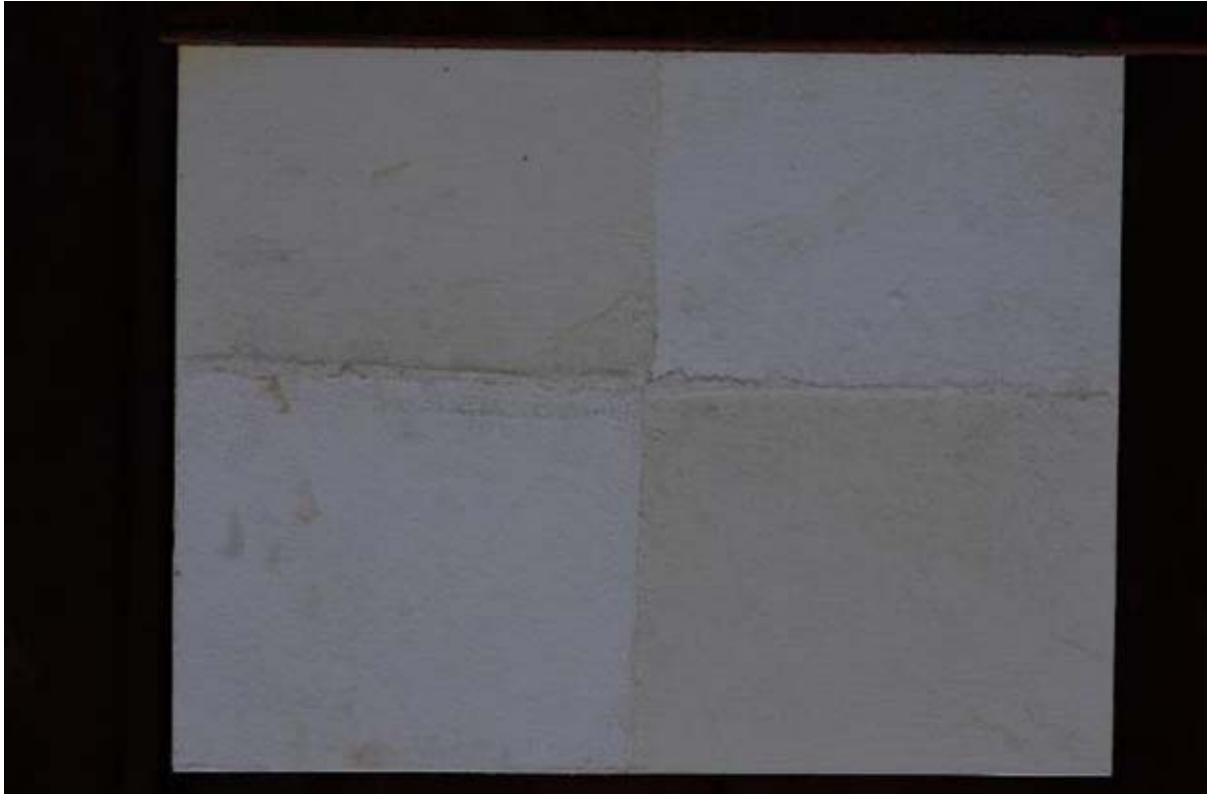
Left plate:

Left test plate. Top left and bottom right: Control paint coated. Top right and bottom left: Intersleek 1100SR coated.

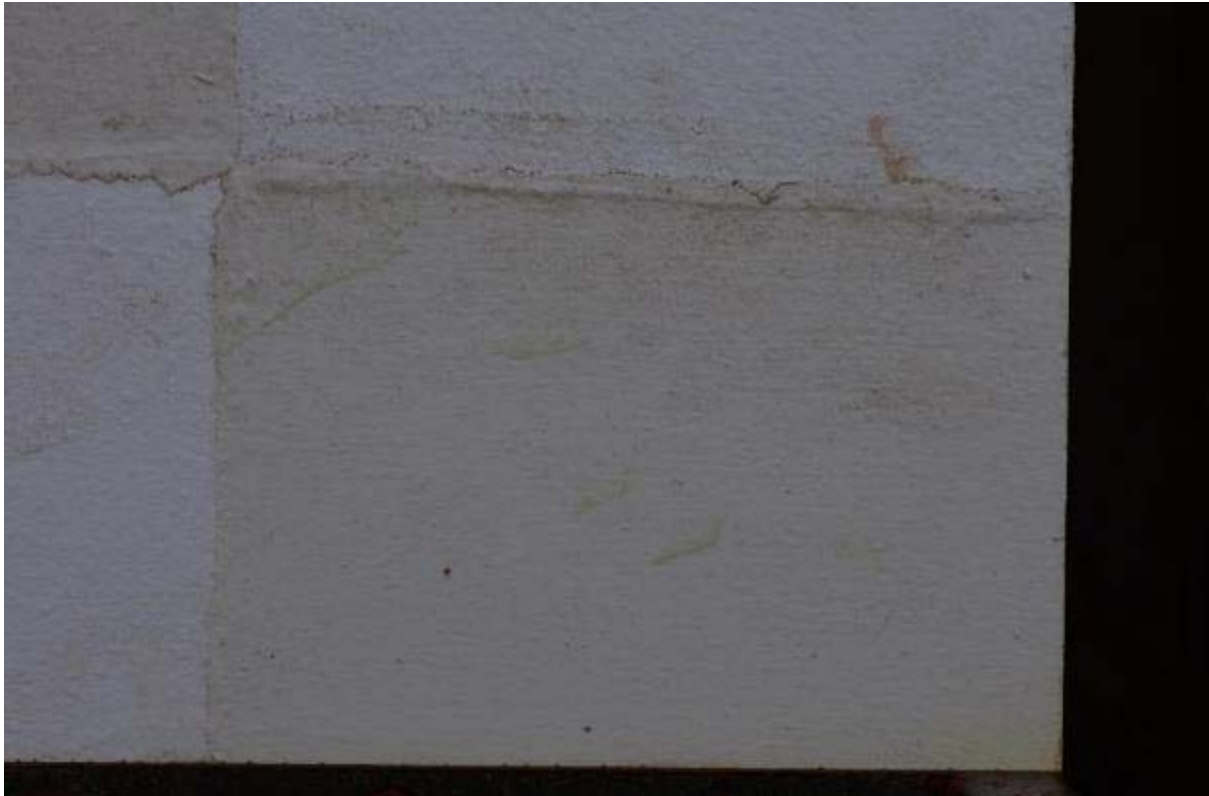
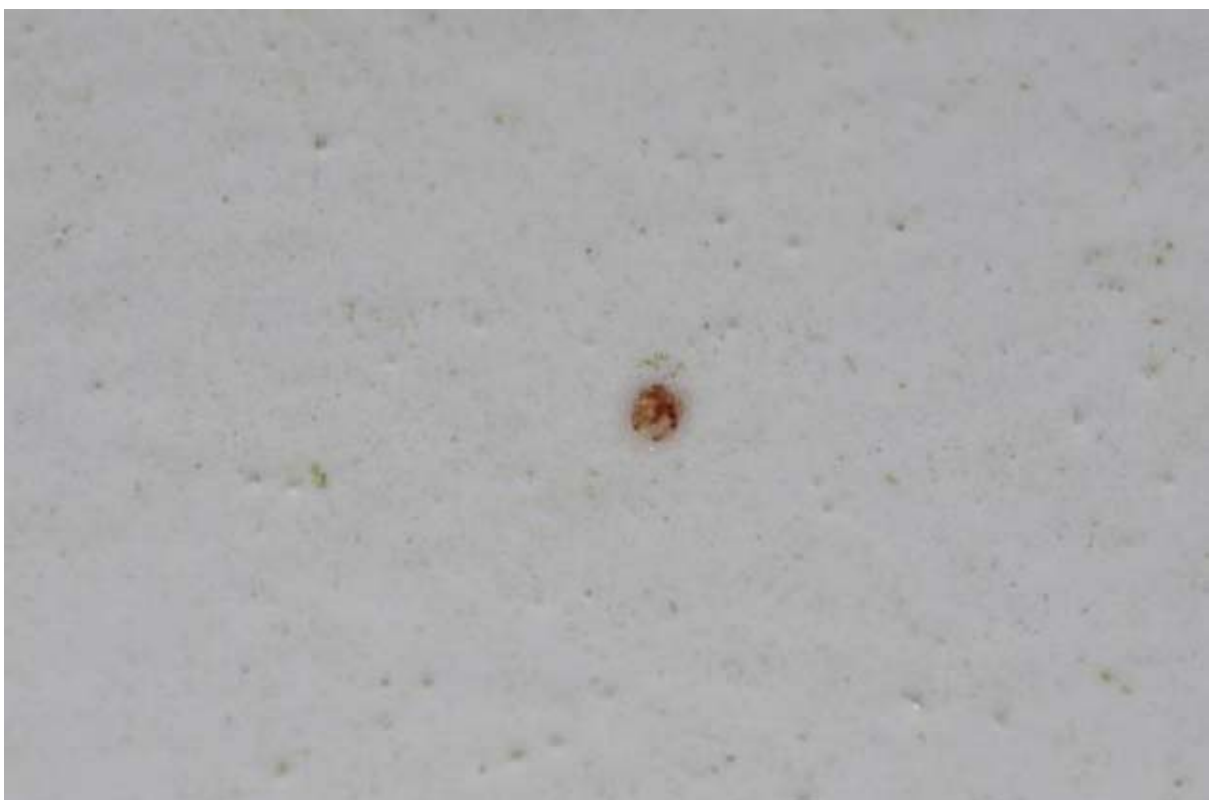
Two colonial ascidians are found on quadrant 4 (Control paint):

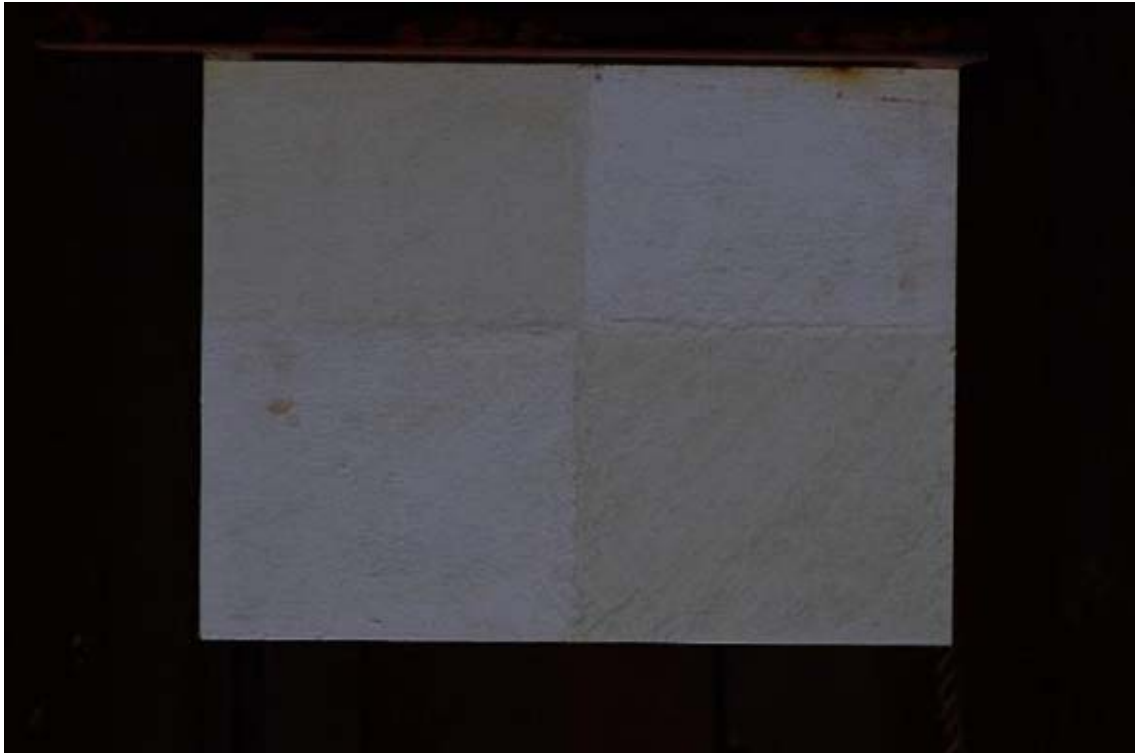
Right plate:

Right test plate. Top left and bottom right: Control paint coated. Top right and bottom left: Intersleek 1100SR coated.

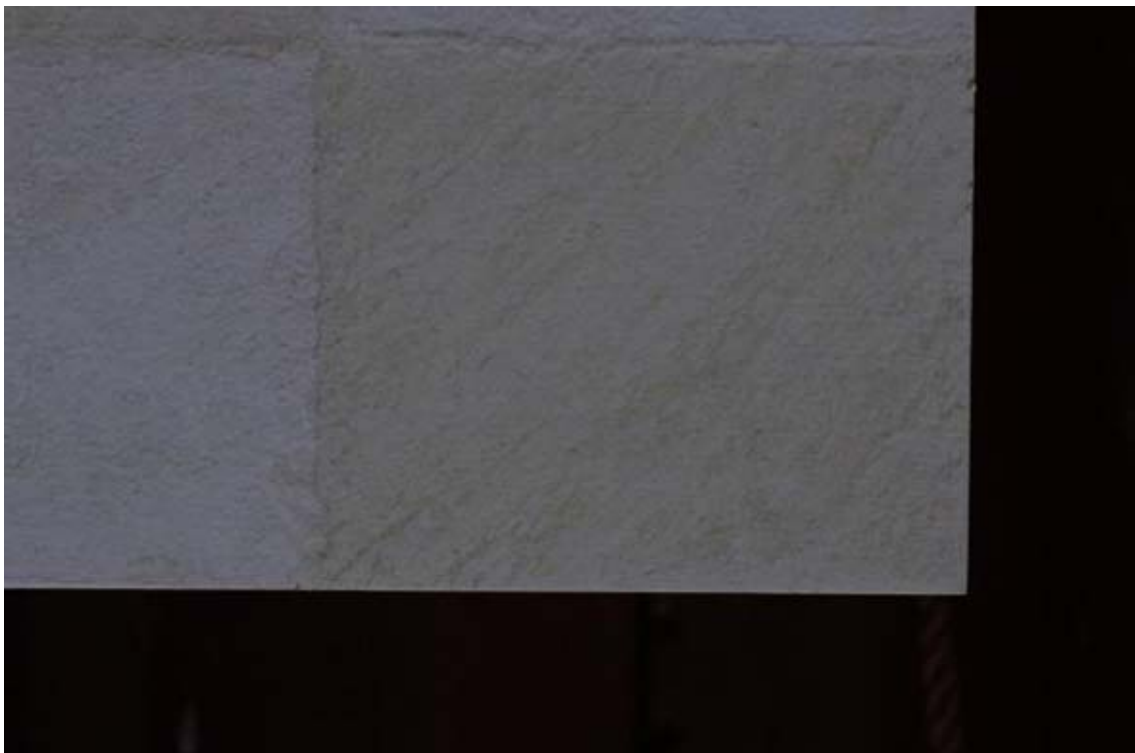
No macrofouling observed on the plate, but greenish streaks are seen on the painted surfaces:

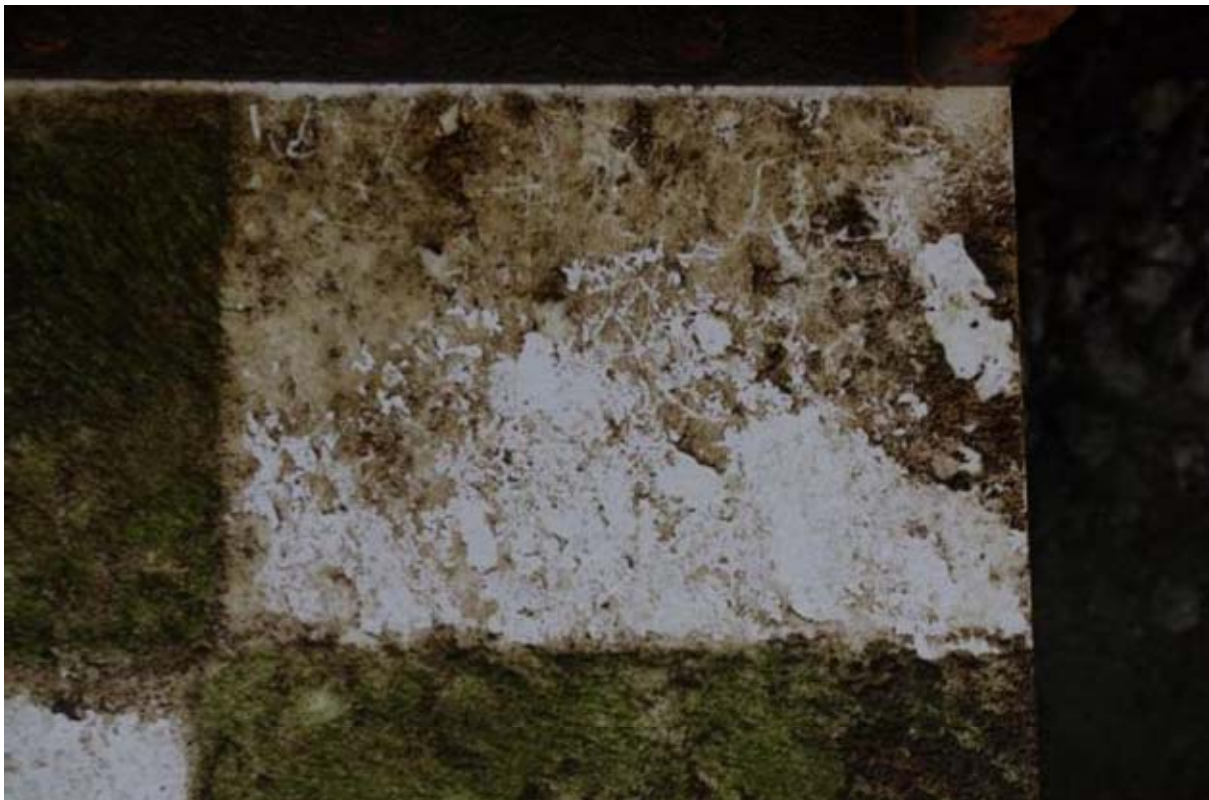
Quadrant 2, note zig-zag patterns of grazing organisms:

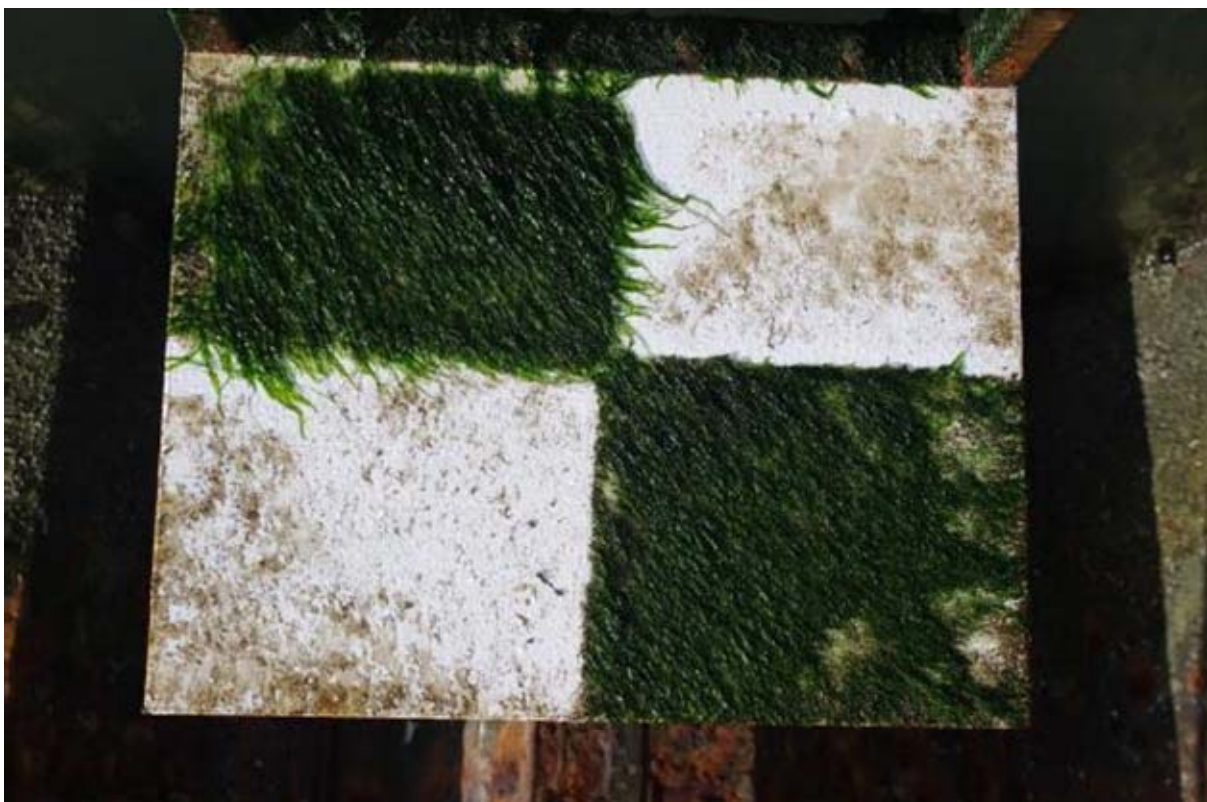
Left plate:

Dense cover of green macroalgae on Control paint coated surfaces. Barnacles visible in lower right corner. Intersleek surfaces show biofilm/silt cover.

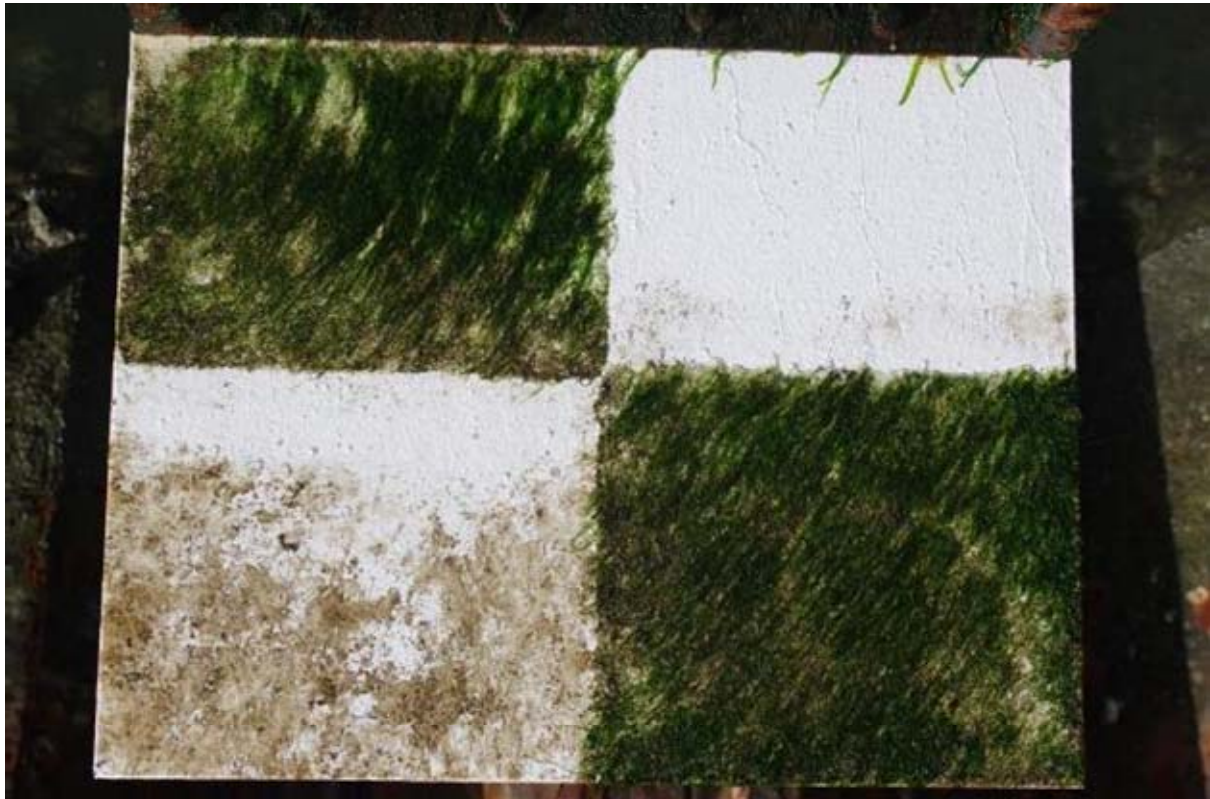
Right plate:

Dense cover of green macroalgae on Control paint coated surfaces. Barnacles visible in upper left corner. Intersleek surfaces show biofilm/silt covering, most prominent in lower left corner.

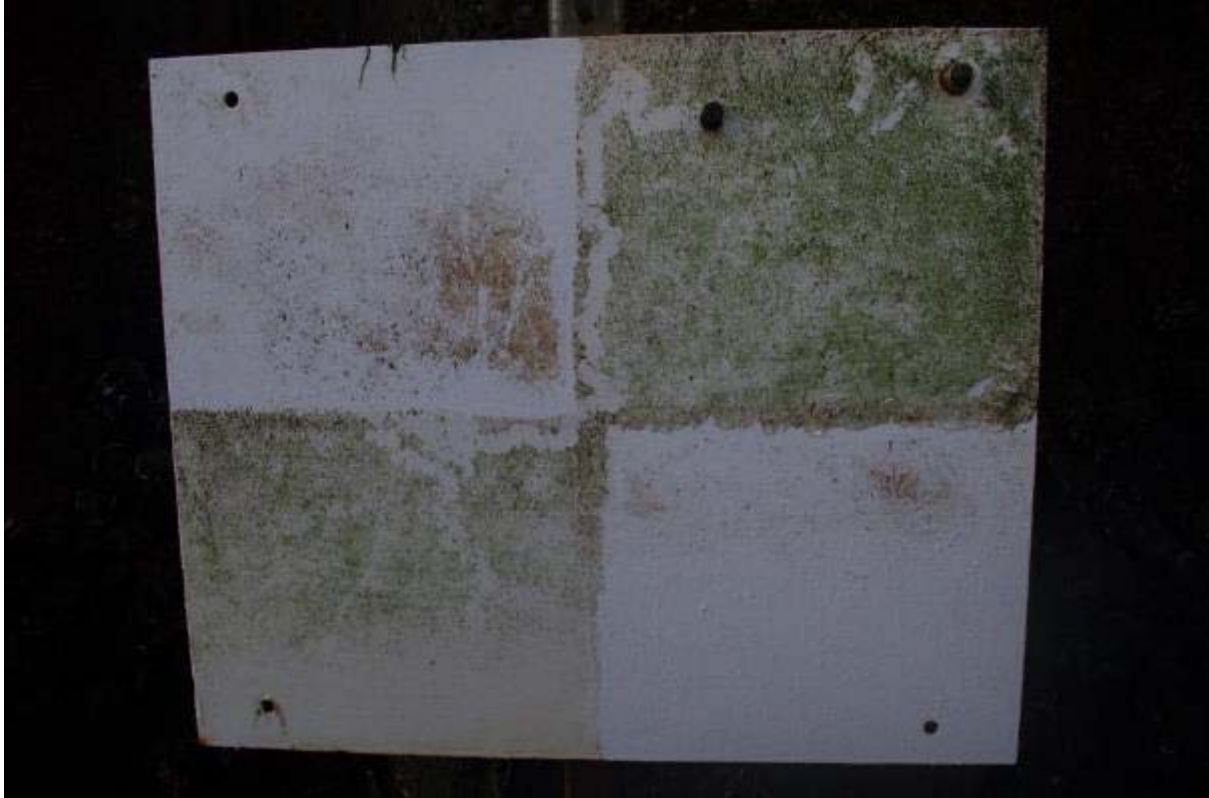
Control plate:

Growth of small green macroalgae on Control painted surfaces. Small worm tubes are also visible. These surfaces show a grazing trail of the snail *Littorina littorea*, the snail itself is present in the top right panel. In the path of the snail small barnacles are visible. Intersleek surfaces show patches of silt/biofilm.

Control plate. Top left and bottom right: intersleek 1100SR coated. Top right and bottom left: Control paint coated.

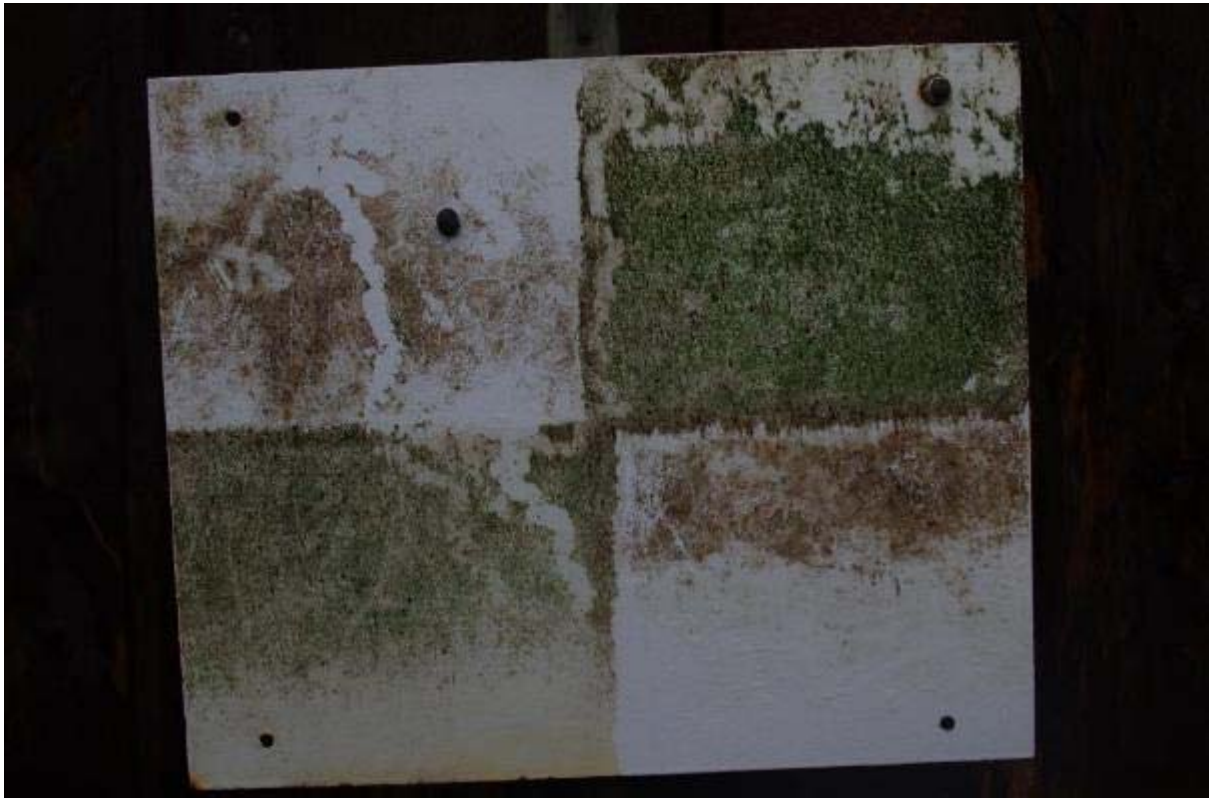
Control plate:

Control plate recovery from NIOZ fyke boat. Recovery was difficult as rusty support pipe causes plate to get stuck often. Some grease helped.

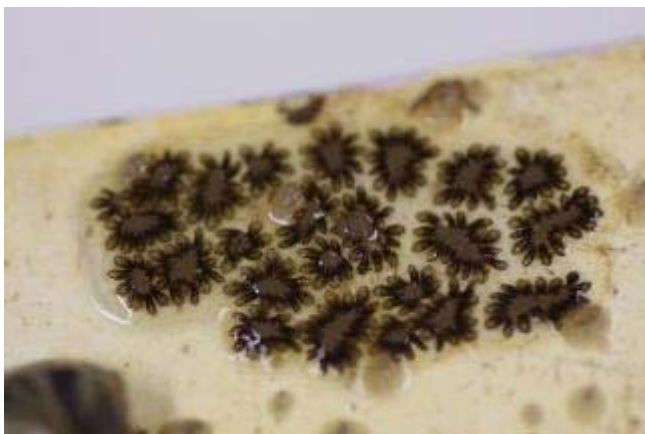
Colonial ascidian *Botrilloides schlosseri* found on Control paint

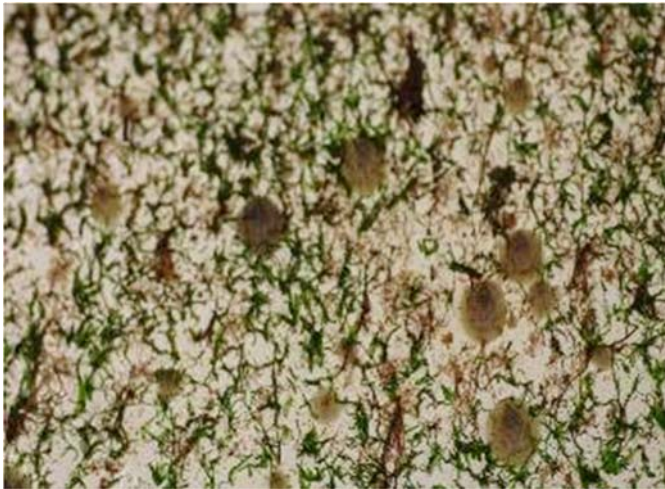
Semibalanus barnacles and macroalgae cover on Control paint control plate
