Shoal margin collapses in the Western Scheldt Estuary

W.M. van Dijk¹, D.R. Mastbergen², G.A. van den Ham² & M.G. Kleinhans¹

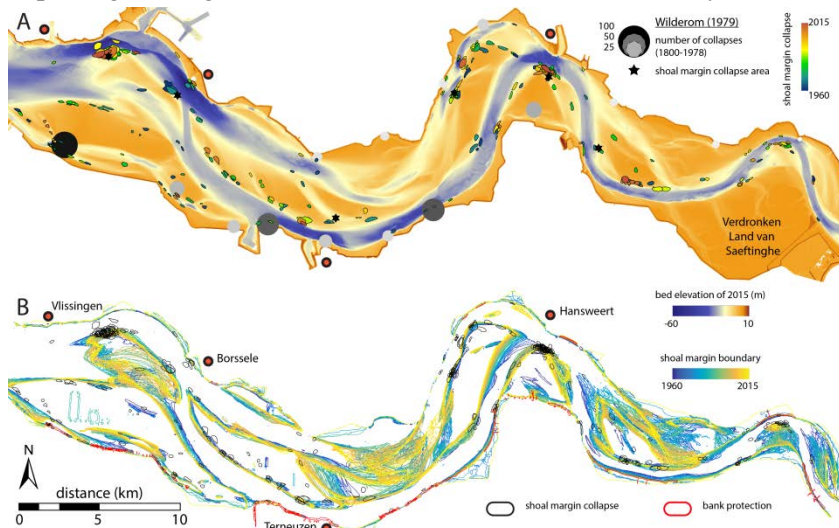
We identified 292 shoal margin collapses along a 300 km long shoal margin boundary. Shoal margin collapses occur at locations where the bar-to-excess width ratio is greater than 1 and where shoal margin migration is low (in the Netherlands often defined by bank protection works, Wilderom 1961-1973), whereas no collapses occur at locations where shoal margin migration is high (see Figure). The average shoal margin collapse area is about 34,000 m² and has an average volume of 100,000 m³, meaning that the average thickness is about 3 m. The shoal margin collapse geometry is best represented by a ¼ ellipsoid. The probability of occurrence formula identified low probabilities for the shoal margin collapses as the average relative slope height was only 11 m and the average relative slope gradient only 6° for the collapsed shoal margins. Nonetheless, by applying various threshold values for the probability of occurrence, we found that the true positive rate was 2.5 times higher than the false positive rate when 50% of all the shoal margin collapse locations were predicted. So, we assume that a flow slide is predicted, if the calculated probability is 10⁻⁷%.

A. DEM of the Western Scheldt Estuary of 2015 with channel/shoal margin collapses according to Wilderom (1800-1978) and new identified shoal margin collapses from 1959-2015. **B.** Shoal margin boundaries over time showing locations of high and low migration, where collapses mainly occur around low/no migration of the shoal.
