The influence of concretion on the long-term corrosion rate of steel shipwrecks in the Belgian North Sea

Kris De Baere , Sven Van Haelst , Igor Chaves , Deirdre Luyckx , Krista Van Den Bergh , Kim Verbeken , Ewoud De Meyer , Katrijn Verhasselt , Raf Meskens , Geert Potters & Rob Melchers

^aAntwerp Maritime Academy, Antwerp, Belgium; ^bFlanders Maritime Institute (VLIZ), Ostend, Belgium; ^cCentre for Infrastructure Performance and Reliability, University of Newcastle, Callaghan, Australia; ^dOCAS, Zelzate, Belgium; ^eDepartment of Materials, Textiles and Chemical Engineering, Ghent University, Ghent, Belgium

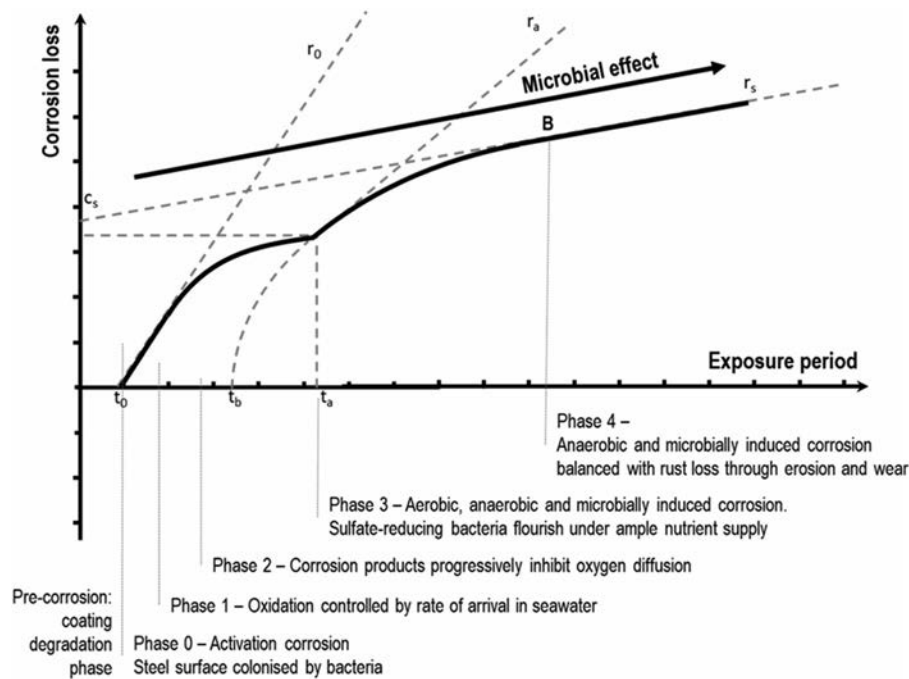
Figure 1. Multi-phase model for long-term corrosion in marine environments with indication of the parameters defined in the text and in Table 1. Long-term anaerobic corrosion rate becomes linear at $t > B$, due to a possibly increasing importance of microbiological influences over the involvement of oxygen. Figure based on Melchers [10].

The present study applies the bi-modal model originally proposed by Melchers [9], largely because it is based on physical and electrochemical principles. The model is robust, is related to probabilistic principles, and can take into account uniform as well as pitting corrosion, aerobic and anaerobic conditions, as well as bacterial, environmental, and anthropogenic influences. The model consists of five phases (Figure 1). Phases 0, 1 and 2 are predominantly oxygen controlled while phases 3 and 4 are largely under anaerobic conditions. In the idealised case, the aerobic corrosion process starts with an initial instantaneous corrosion rate r_0 . Owing to a progressive reduction of oxygen available at the corrosion interface the corrosion rate diminishes and becomes nearly zero, at t_a . However, the corrosion rate then increases under the influence of anaerobic and possibly bacterial corrosion processes with an initial corrosion rate of r_a to reach a constant rate r_s at time point B.

curve with slope r_s and intercept c_s (Figure 1):

where c_s is the corrosion loss back-projected to $t = 0$ (in mm) (Figure 1), t is the total time of immersion (in years), t_0 is the time to which the original coating can be considered to remain substantially protective (in years) and r_s is the anaerobic steady corrosion rate (in mm y^{-1}). R_p is a factor that can be used to model the impact of microbiologically influenced corrosion (MIC) [10]. It is a function of the concentration of dissolved inorganic nitrogen (DIN) in the local sea water environment, with

A comparison of the long-term linear model (displayed along with its 95% confidence and prediction bands in Figure 4) with the linear stage 4 of Melchers model (as defined in Figure 1) shows that the linear part of the latter has a much higher long-term corrosion rate. The corrosion rate for the ship wrecks considered, all located in the Belgian part of the North Sea (BNS), is less than one-third of the corrosion rate predicted by Melchers' multi-phase model ($r_s = 0.054 \text{ mm y}^{-1}$) (Table 1).

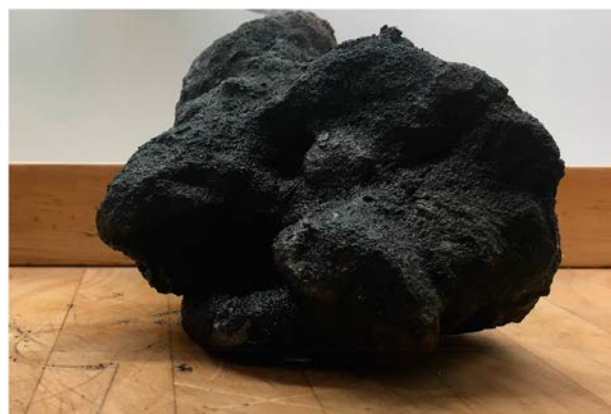
Figure 3. Piece of historic chain used for SEM-EDX and XRD analysis of the concretion layers.

In a first series of measurements, X-ray diffraction (XRD) was used to determine a preliminary composition of the concretion around the metal chain shackle a D8 Discover XRD (Bruker), set-up for phase identification with a Co tube ($K\alpha_1 = 1.78897 \text{ \AA}$) with a generator at 35 kV and 40 mA, a 1 mm slit behind the Polycap, long soller slits 0.35° in front of the detector, the lynx eye detector in 0 D mode with an opening of 13 mm, and a q/q configuration (continuous locked couple scan). The crystalline phases present in the analysed sample were identified by comparing the positions of diffraction peaks in the experimental pattern with those present in (experimental and simulated) patterns of known samples available in a database (Powder Diffraction File, International Centre for Diffraction Data, Swarthmore/USA).

Next, the chain was cut into pieces of approximately 5 cm. One of the pieces was forwarded to the University of Newcastle in Australia for detailed analysis. Upon reception, the sample was stored in a dry and secure location under ambient conditions for about 6 weeks prior to testing. The chain pieces

were dried in an oven at 110°C for 24 h prior to SEM/EDS and XRD testing. Target areas of interest were marked and aligned in the PANalytical X'Pert Pro MRD XRD for analysis, which was used with a continuous scan type, step time of 135 s, at 25°C using a Cu anode with beam generator set to 40 mA, 40 kV.

To prepare the sample for Zeiss SIGMA VP SEM/EDS analysis, the chain was ground flat using a 400 grit silica carbide belt sander and then broken open to obtain suitable samples for Scanning Electron Spectroscopy (SEM) with Electron Dispersive Spectroscopy (EDS) analysis. The Back Scatter Electron Detector was used for observation when necessary, while the analysis was primarily completed using the Secondary Electron Detector at a 20 keV beam intensity. When performing EDS scans, all zones had the same magnification and the scan was performed for the same duration; sufficient time was allowed (approx. 10 min) until no further changes to peak count were detectable.

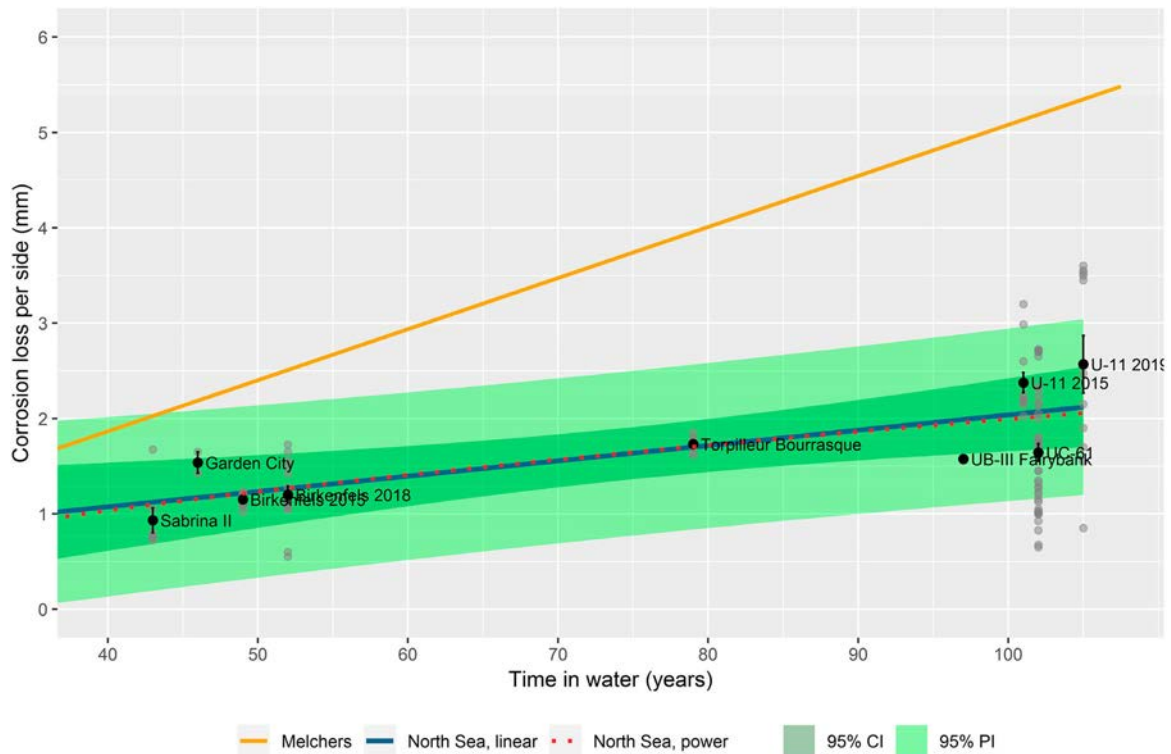
Figure 4. Corrosion loss per side (mm) versus time in the water in years; the blue line corresponds with the linear North Sea model with a green 95% confidence and prediction bands; the orange line corresponds with the Melchers model as parametrised for the North Sea; the red dotted line corresponds with the North Sea power model.

To make an estimate of the long-term corrosion rate r_s , specifically for the Belgian North Sea wrecks, the results of the average measured corrosion losses on the shipwrecks were plotted against the period of immersion. The empirically obtained trend (Figure 4) was compared with the multi-phase model of Melchers at 12.5°C in the absence of MIC [2].

A long-term linear model was also fitted on the data (Equation (5)). As can be seen in Figure 4, the long-term evolution of average corrosion loss differs little between the linear and the non-linear trends. The linear model was therefore adopted:

Equation (5) is essentially the same as Equation (1), except that in Equation (5), time t is the period (years) after sinking. The long-term corrosion rate is estimated at $r_s = 0.016 \text{ mm y}^{-1}$ (95% confidence interval [0.0053 ; 0.0268]), while the intercept is given by $c_s = 0.43$ (95% confidence interval

$[-0.42; 1.28]$). This model is statistically significant ($p = 0.009 < 0.05$).
