Effect of a 100 Watt ultrasound transmitter on marine fouling

Lodewijk van Walraven & Louis Peperzak

This report is part of project DMEC WP 3.3.

Texel, April 2018
NIOZ Royal Netherlands Institute for Sea Research

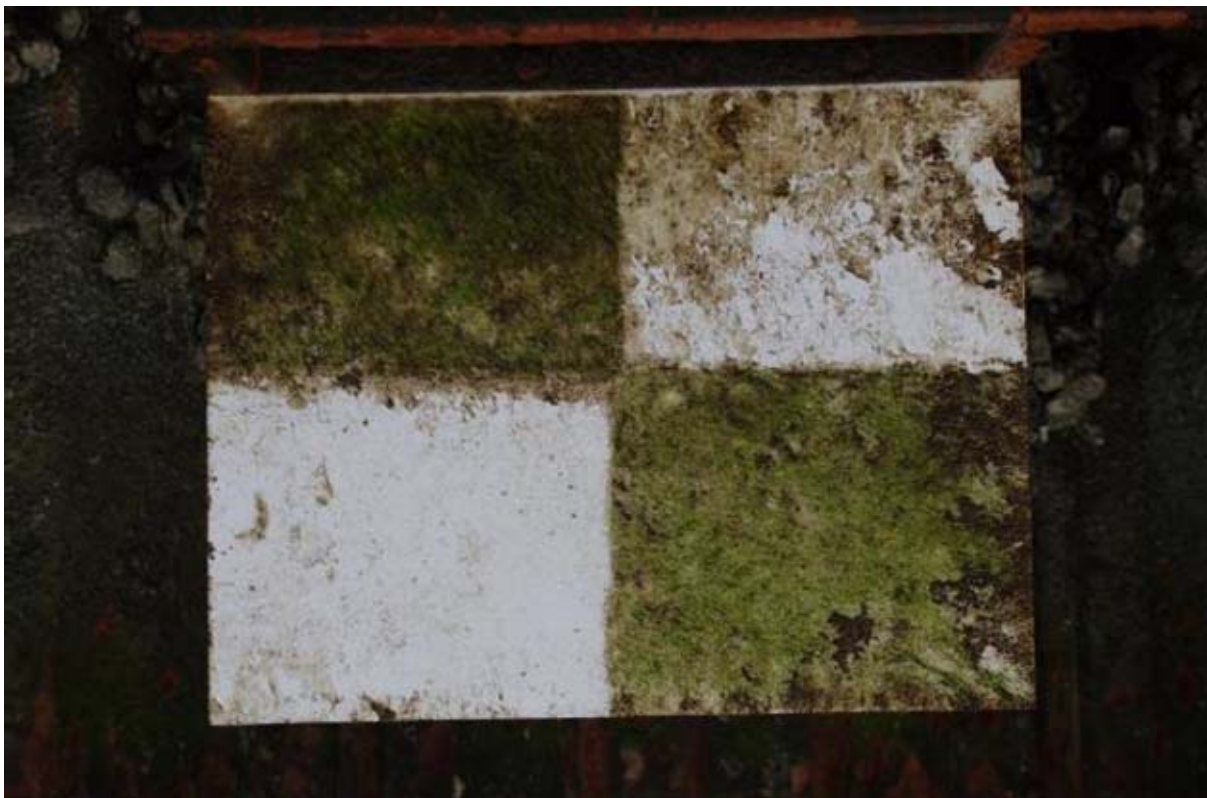
Left plate:

Left test plate. Top left and bottom right: Control paint coated. Top right and bottom left: Intersleek 1100SR coated.

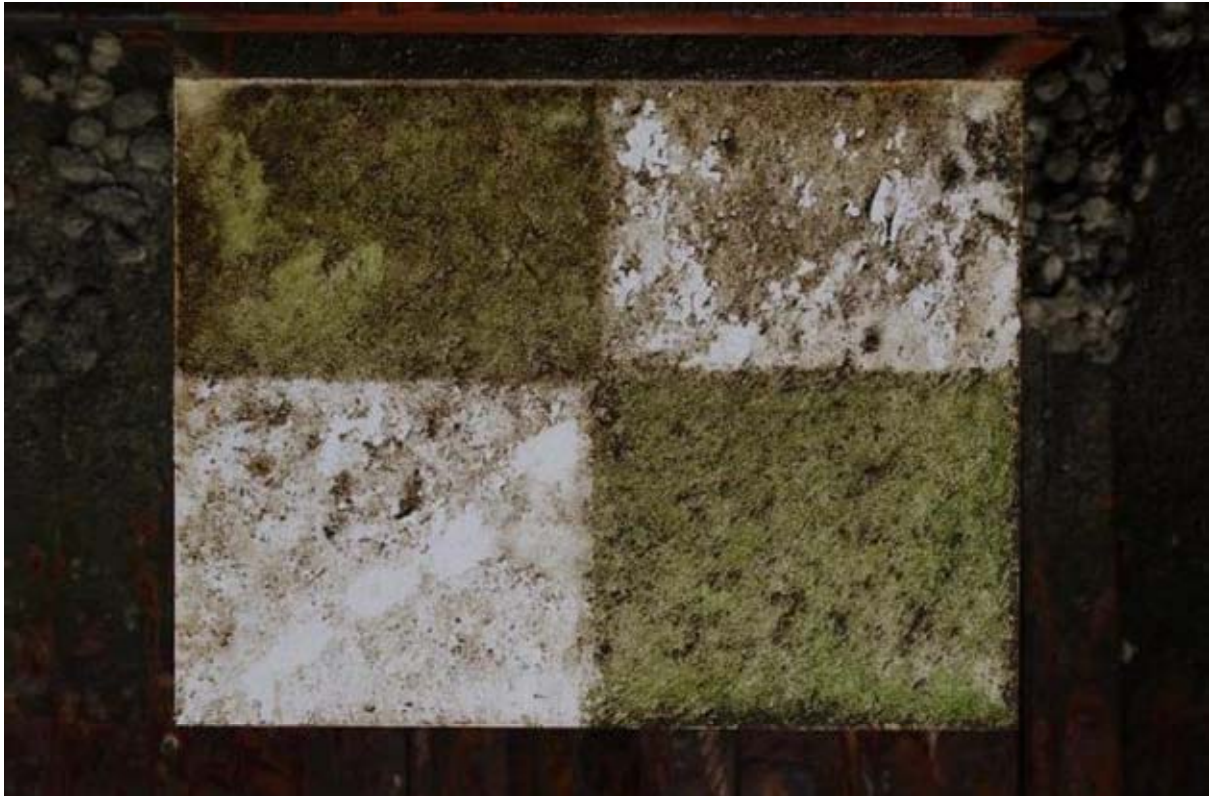
Right plate:

Right test plate. Top left and bottom right: Control paint coated. Top right and bottom left: Intersleek 1100SR coated.

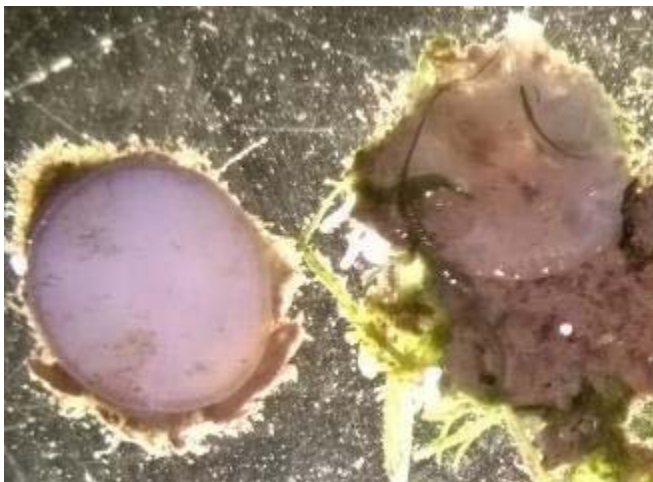
An interesting observation is that on Intersleek coating, only barnacles of the genus *Balanus* were found, and on the control paint coated plates only barnacles of the genus *Semibalanus*. These barnacles have bases made of different materials: *Balanus* have calcified bases and *Semibalanus* have membranous bases. It appears that only barnacles with calcified bases can settle on Intersleek coating.

Comparison of barnacle bases. Left: Calcified base of *Balanus* so. Right: Membraneous base of *Semibalanus* sp.

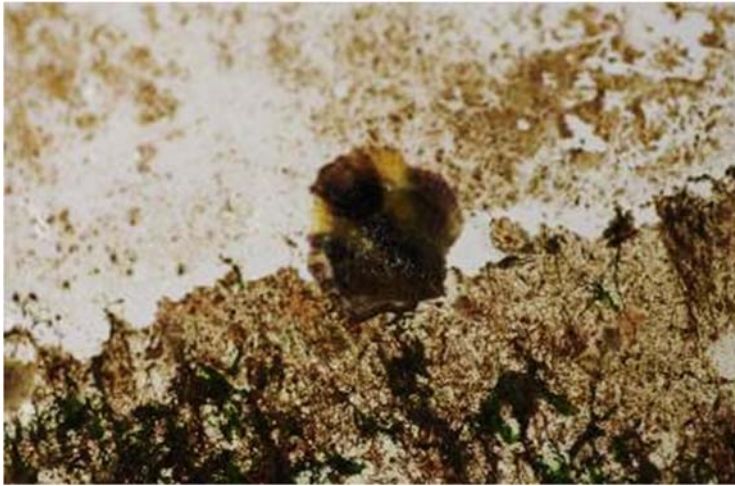
Japanese oyster on the border between an Intersleek and a Control paint quadrant.
