Effect of a 100 Watt ultrasound transmitter on marine fouling

Lodewijk van Walraven & Louis Peperzak

This report is part of project DMEC WP 3.3.

Texel, April 2018
NIOZ Royal Netherlands Institute for Sea Research

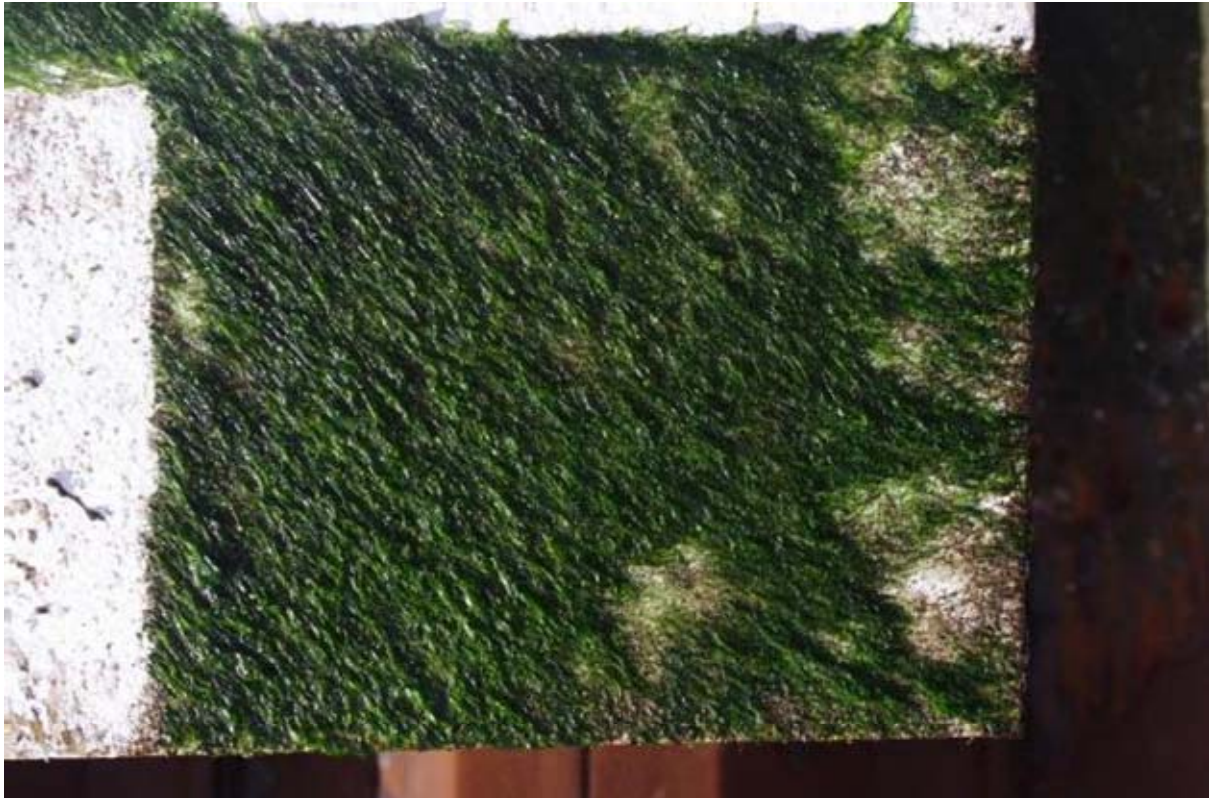
Detail, quadrant 4:

Dense cover of green macroalgae on Control paint coated surfaces. Barnacles visible in upper left corner. Intersleek surfaces show biofilm/silt covering, most prominent in lower left corner.

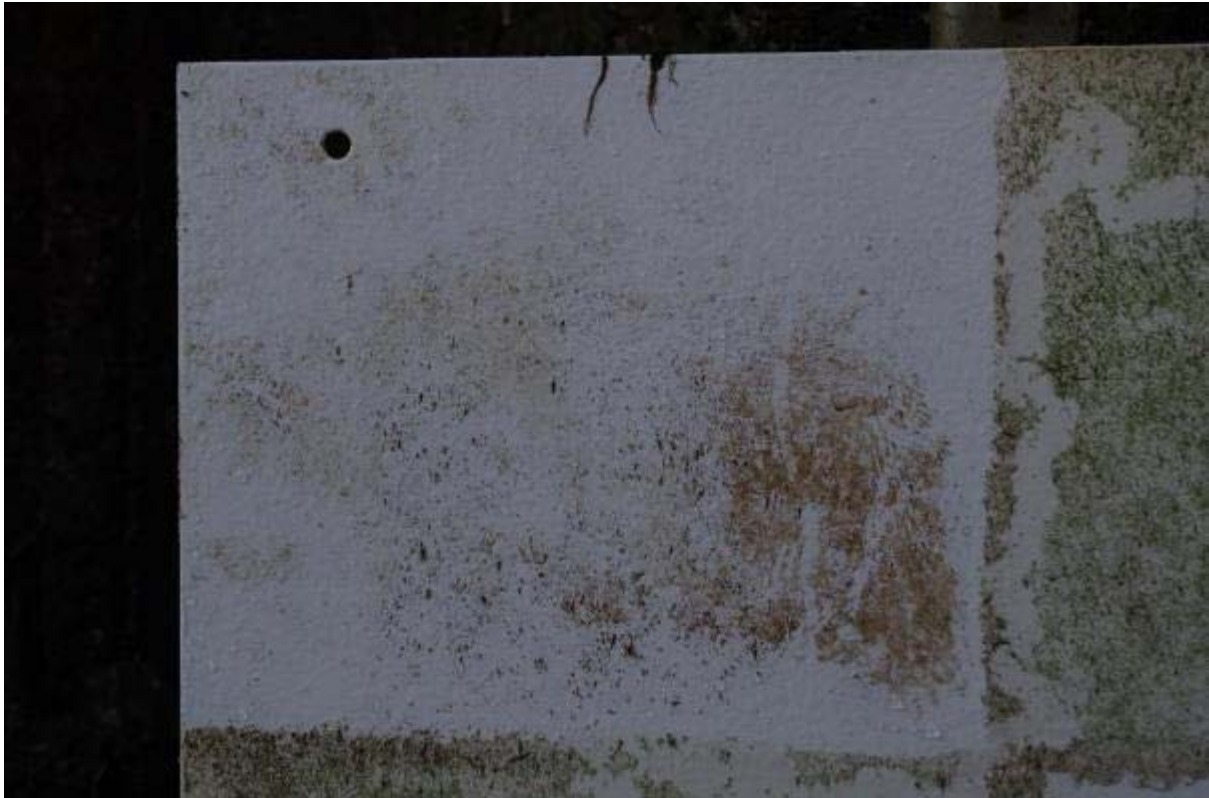
Detail, quadrant 1:

Growth of small green macroalgae on Control painted surfaces. Small worm tubes are also visible. These surfaces show a grazing trail of the snail *Littorina littorea*, the snail itself is present in the top right panel. In the path of the snail small barnacles are visible. Intersleek surfaces show patches of silt/biofilm.

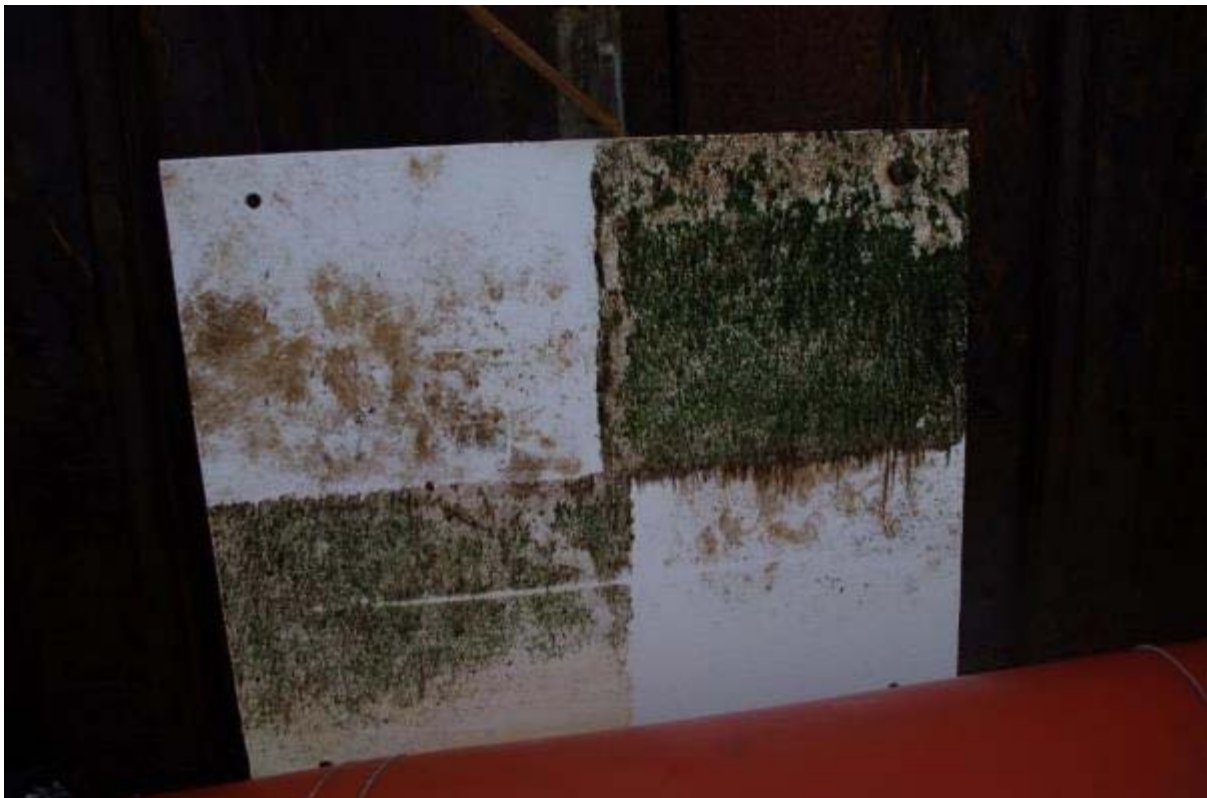
Control plate:

Because of a storm the check of the control plate had to be postponed and carried out using the MOB boat of RV Navicula. Weather conditions (NW 7 bft winds) made it very difficult to take good photographs without damaging either the boat or the plate.

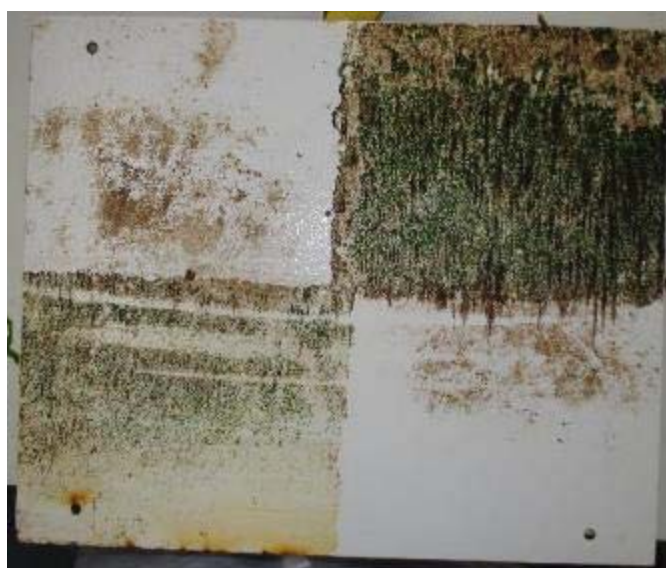
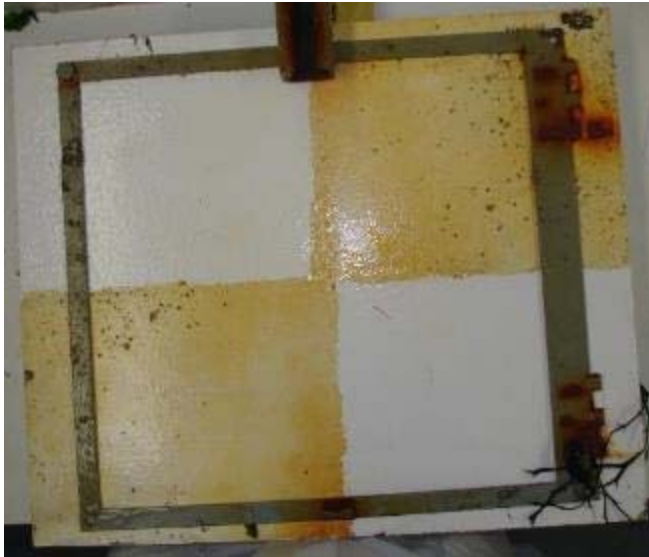
Control plate:

The front and back of the control plate showed different fouling community composition. On the back of the control plate no macroalgae were found, likely owing to the fact that this side was always shaded from sunlight.

On the Intersleek surfaces at the back of the control plate, no fouling organisms were found. On the control painted surfaces several fouling organisms were found: barnacles, hydroids, bryozoans, and ascidians.

On the Intersleek surfaces at the front of the control plate no fouling organisms were found, except for green macroalgae on one quadrant. On the control paint a dense cover of green and red macroalgae was found, together with *Semibalanus* barnacles and encrusting bryozoans.

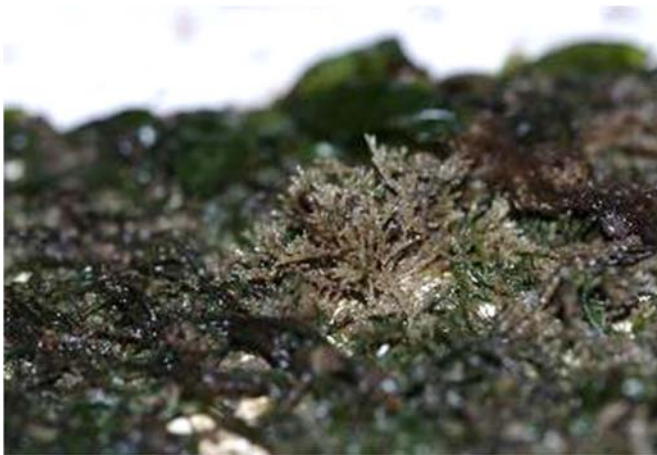
Plumose bryozoan on Control paint.

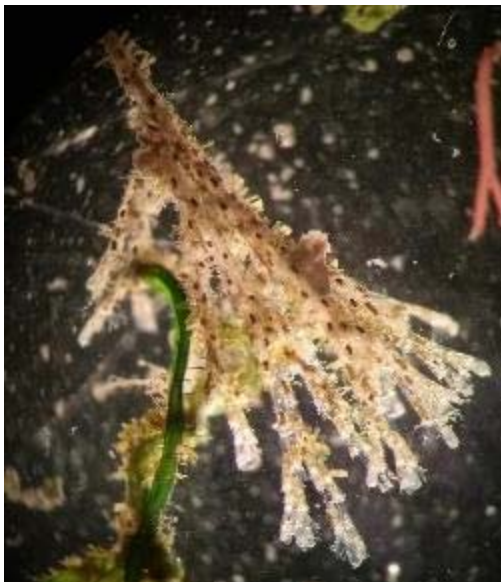
Plumose bryozoan from Control paint, photo through dissection microscope

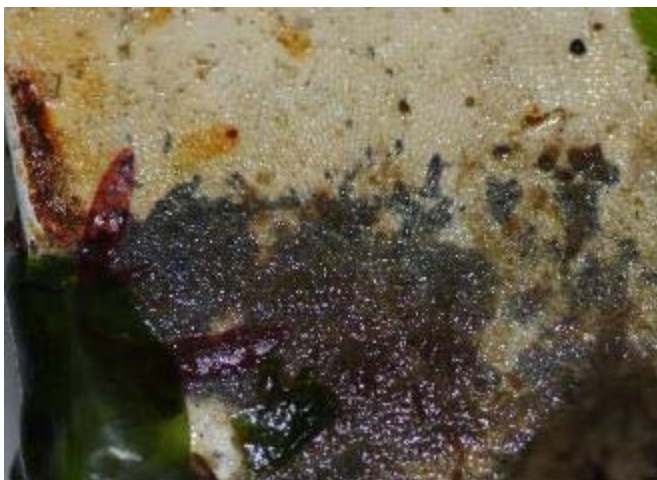
Encrusting bryozoan *Conopeum reticulum* on Control paint

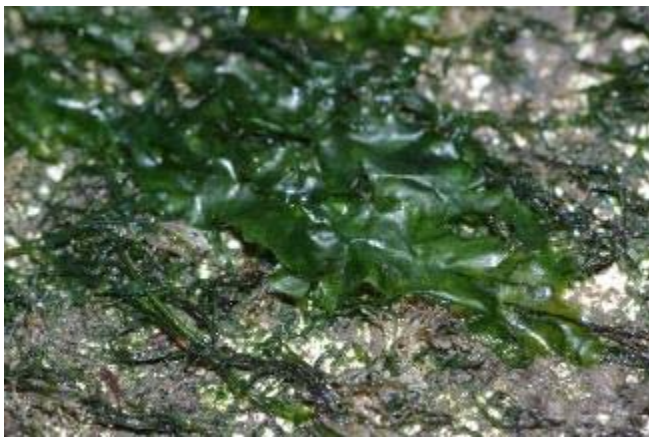
***Ulva* sp. Green macroalgae on Control paint**

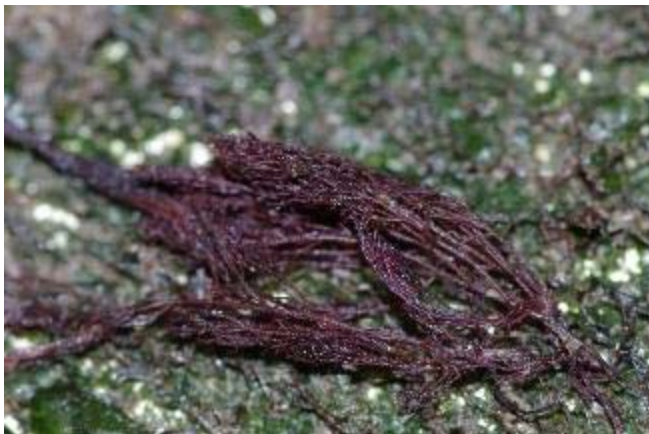
***Ceranium* sp. Red macroalgae on control paint**

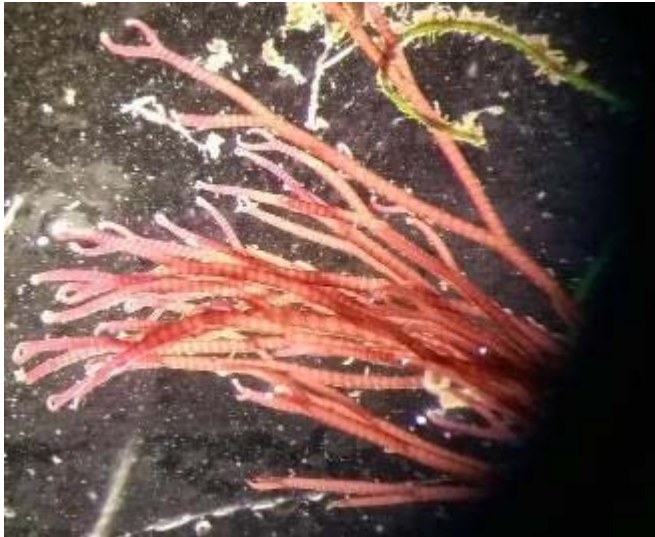
Ceramium sp. Red macroalgae on control paint, photo through dissection microscope

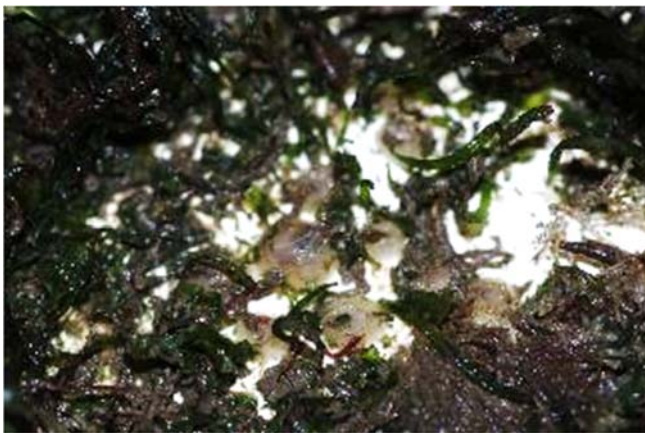
Semibalanus balanoides on Control paint

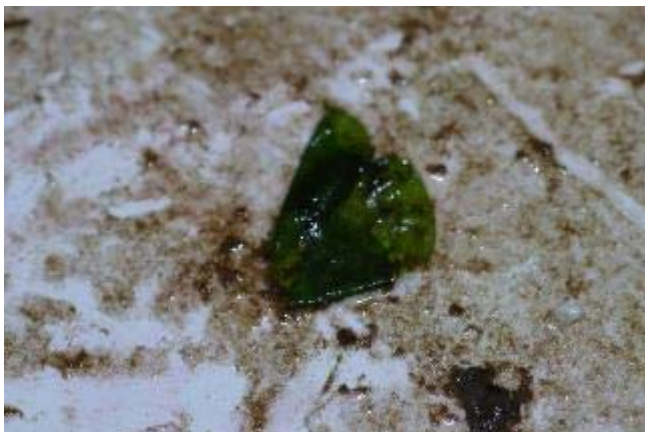
Ulva sp. Green macroalgae on Intersleek

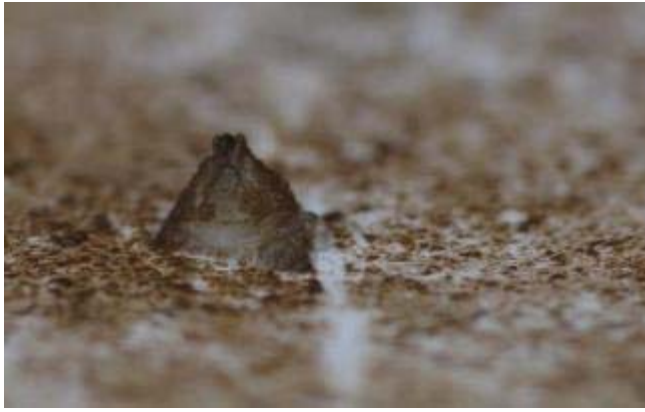
The Intersleek surfaces of the test plates were mainly covered in slimy biofilm, but fouling organisms were observed in low concentrations on Intersleek on several quadrants: red and green macroalgae, *Balanus* sp. barnacles, colonial ascidians, hydroids and tubeworms.

Balanus sp. Barnacle on intersleek

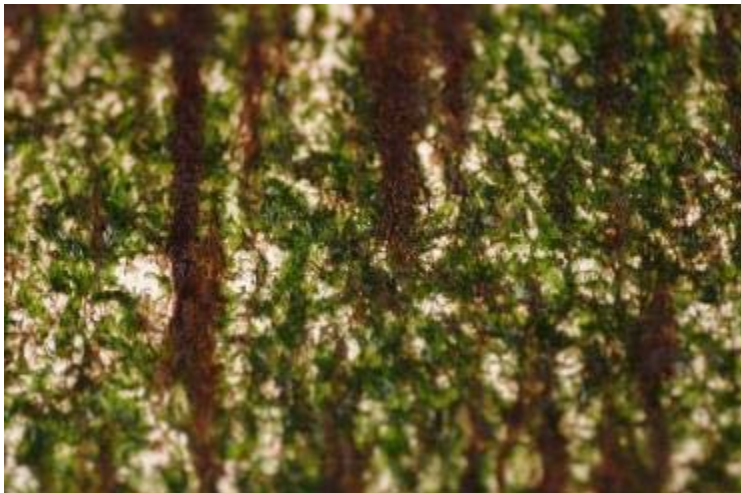
Macroalgae cover on Control paint control plate

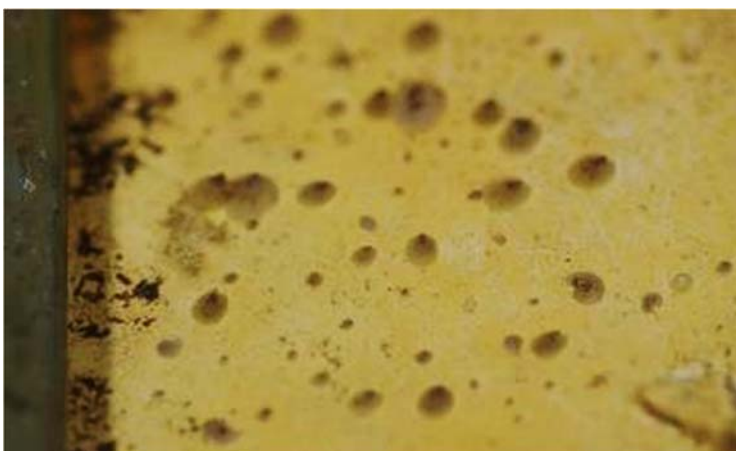
Semibalanus barnacles and *Spigobranthus* tubeworm tubes.
